## Introduction

The examination of failed radioactive solid lithium lenses has not been permitted until recently. Since a method to examine failed lenses has been worked out [1], lenses 21, 20, 17, 18, and 16 have been disassembled and work has begun to understand why these lenses have failed. While the damage produced during the failure of these lenses is obvious, the initial conditions leading to failure are yet to be identified. A fair amount of metallurgical work has been and continues to be done, primarily by the Mechanical Support Department. The purpose of this Note is to document what was found during the lens unfilling and disassembly including the condition of the septum upon removal from the lens body.

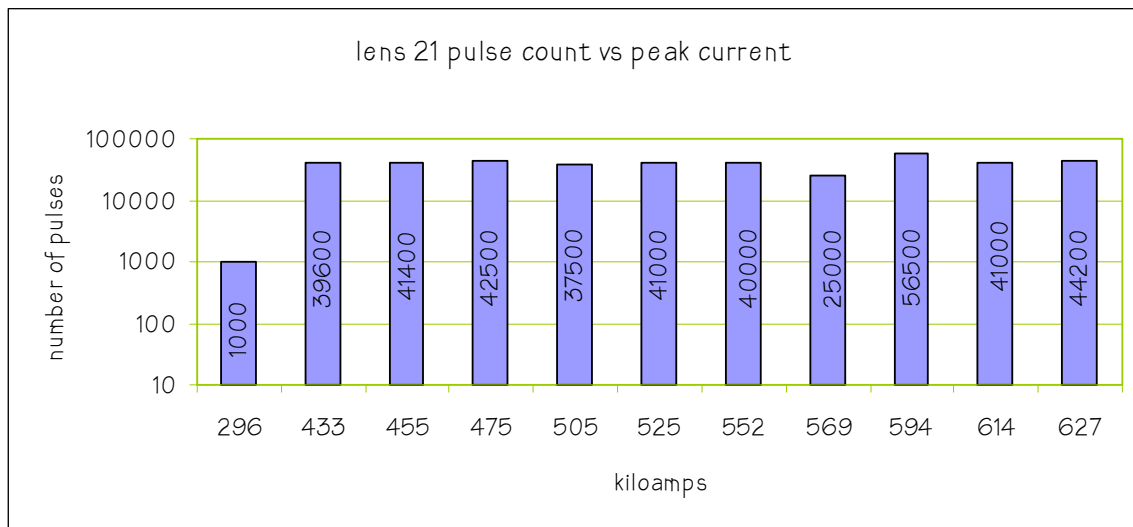
**Figure 1**

Lens 21 was filled in June 1993 with a reported preload of 2,060 psig<sup>1</sup>. It was tested in August 1993 for a total of 409,700 pulses at a maximum peak current of 626,675 amps. Figure 1 contains a summary of the number of pulses tested versus peak current. The desired and achieved gradients were 900 and 940 T/m, respectively.

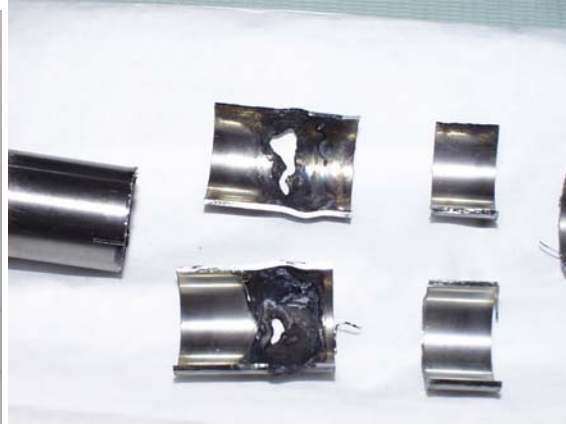
<sup>3</sup> and 12 liters of hydrogen gas were produced during Phase 2. Only about 1/2 to 2/3 of the hydrogen gas produced in Phase 3 was burned which yielded about 1 mCi of tritium. Total tritium produced in phase 2 is estimated to be 1.5 to 2 mCi. Damage in the inner conductor was extensive near its center. The inner conductor appeared to be burned through circumferentially (dark crescent shape in photo) and some long longitudinal cracks were found along the length of the inner tube.

**Photo 2 - Lens 21 inner titanium tube sections**

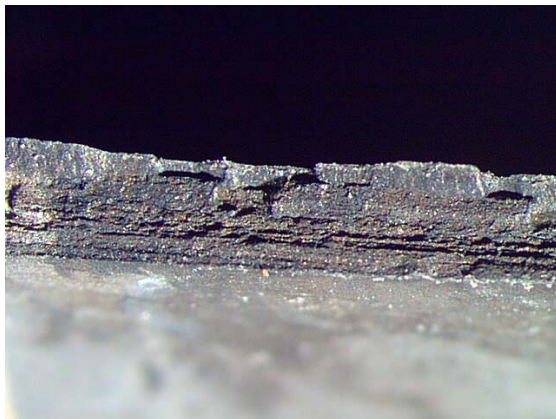
**Photo 3 - edge view of Lens 21 crack**

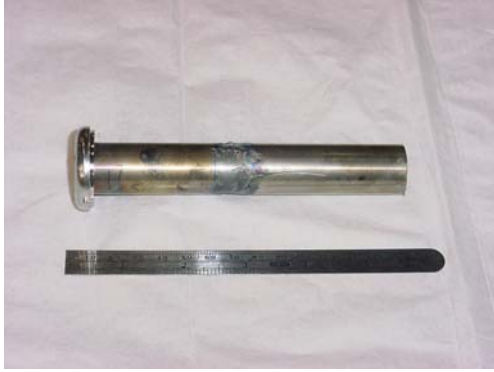
Lens 17 was disassembled over the period October 3 to October 31, 2001. Before Lens 17 could be unfilled, the end flanges had to be removed so that the broken water lines could be repaired to prevent lithium metal or water leaks out of the water cooling lines. A total of 23 grams of lithium was removed during four attempts in Phase 1. Seven to eight liters of hydrogen gas were produced during Phase 2. Upon disassembly, an unknown compound was found plugging one of the fill ports. This compound probably formed because the lens water cooling passages had not been dried out before the lens was put into storage. The presence of this compound prevented establishing water flow through the lens body and as a consequence, there was still some lithium metal present when the lens body was disassembled. The hydrogen gas burned in Phase 3 yielded about 7.7 mCi of tritium. Photos of the intact inner conducting tube and some tube sections are included below. Additional metallurgical examinations are being planned for the inner conducting tube of Lens 17.

**Photo 8 – Lens 17 inner tube removed from septum**

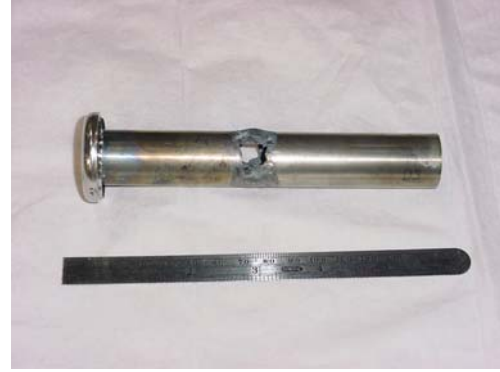
**Photo 9 – another view Lens 17 inner tube**

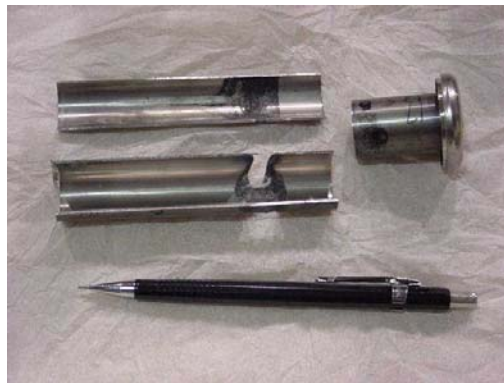
**Photo 10 – Lens 17 inner tube after sectioning**

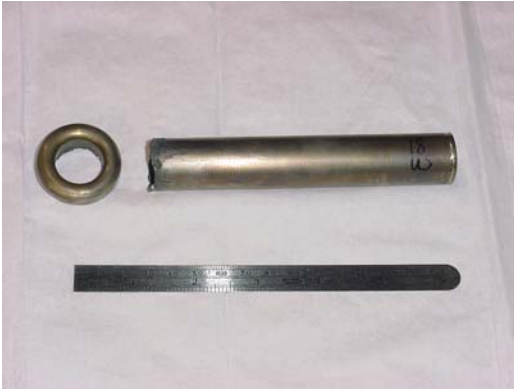
Lens 18 was disassembled over the period November 19 to December 5, 2001. One attempt was made to unfill Lens 18 with Phase 1 and only 1 cc of lithium was removed. Forty liters of hydrogen gas were produced during Phase 2. The hydrogen gas burned in Phase 3 yielded about 26 mCi of tritium. Damage to Lens 18 was rather unique. In this case the downstream end of the inner conducting tube (not the welded end) was burned off entirely. There was no evidence of any cracks. Photos of the inner conducting tube removed from the septum assembly and some tube sections are included below. Additional metallurgical examinations are being planned for the inner conducting tube of Lens 18.

**Photo 11 – Lens 18 inner conducting tube removed from septum**

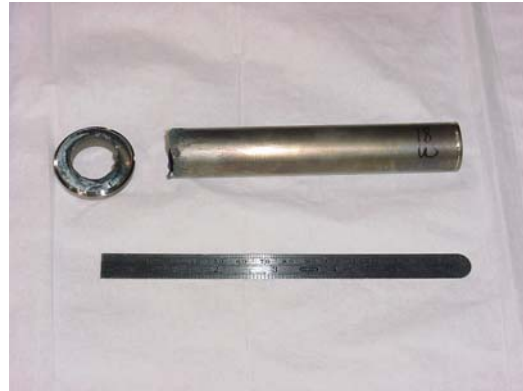
**Photo 12 – Same as Photo 11 except ring reversed**

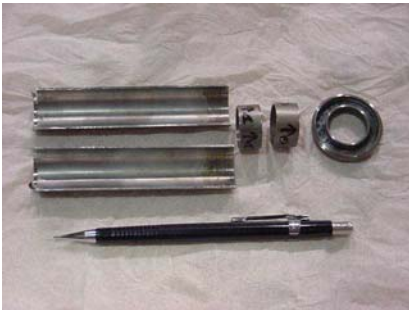
**Photo 13 – Lens 18 inner conducting tube after sectioning**

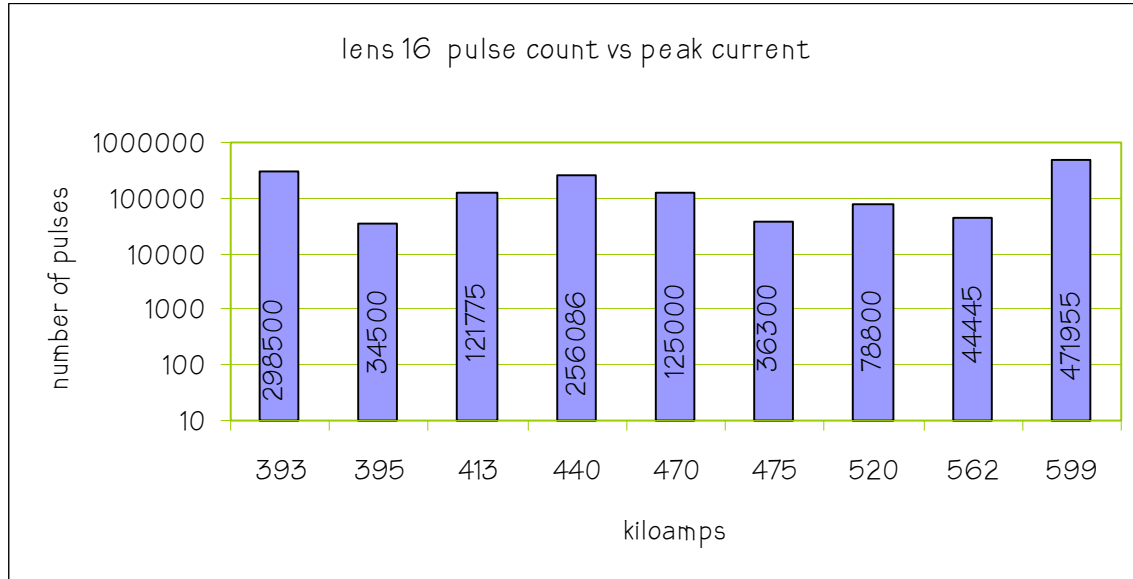
Lens 16 was filled February 9, 1990 with a reported preload of 2,560 psig. It was installed on the test station on five different occasions including March 1990, May 1990, July 1990, December 1990, and April 1991. Lens 16 had a total of 1,467,361 pulses on the test station at a maximum peak current of 599,314 amps. Figure 5 contains a summary of the number of test pulses versus peak current. The desired and achieved gradients at the test station were 900 and 936 T/m, respectively.

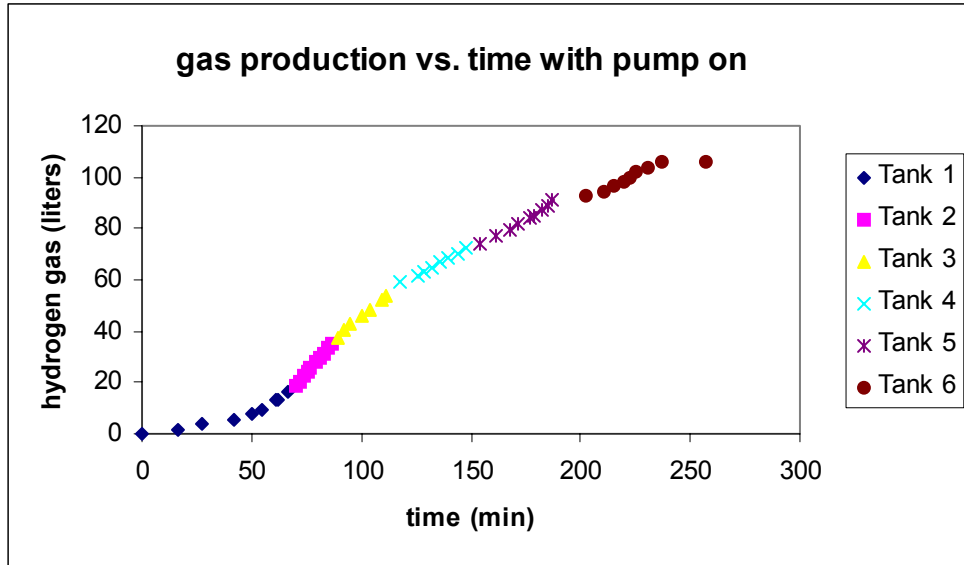
Figure 6

Lens 16 was disassembled over the period March 27 to April 4, 2002. Lens 16 was unfilled utilizing only Phase 2 and the nested tube arrangement in which 106 liters of hydrogen gas were produced. The total gas production versus time the pump was running is plotted in Figure 6. Lens 16 provided a unique opportunity to measure the total tritium associated with the lens both in gaseous and aqueous forms. The lithium was completely intact in this lens since the septum was not destroyed. The total tritium recovered from hydrogen gas was 17.7 mCi while the total tritium recovered in the Phase 2 tank water was 0.7 mCi. The total estimated proton beam intensity on target over the Lens 16 operating life was  $6.4E18$  protons. A total of 18.4 mCi was collected from this lens. In References 1 and 2 the predicted total tritium was 4 and 0.9 Curies. The total tritium measured is a factor of 50 times less than predicted.

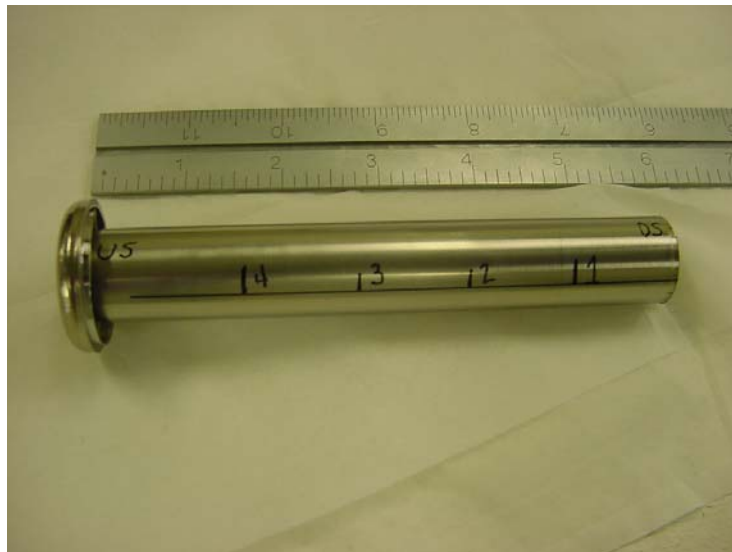
As expected, there was no evidence of damage in the Lens 16 inner conducting tube. A photo of the inner conducting tube removed from the septum assembly showing marks for intended tube sections are included below.

Photo 14 – Lens 16 inner tube removed from septum prior to sectioning

Metallurgical examinations are being planned for the inner conducting tube of Lens 16 to look for evidence of onset of cracking, pitting, or other evidence of fatigue.
